FLOOD HAZARD EVALUATION  
FOR DIVIDE AND WILD CREEKS  
GLACIER NATIONAL PARK

Technical Report NPS/NRWRD/NRTR-91/02

August 1991

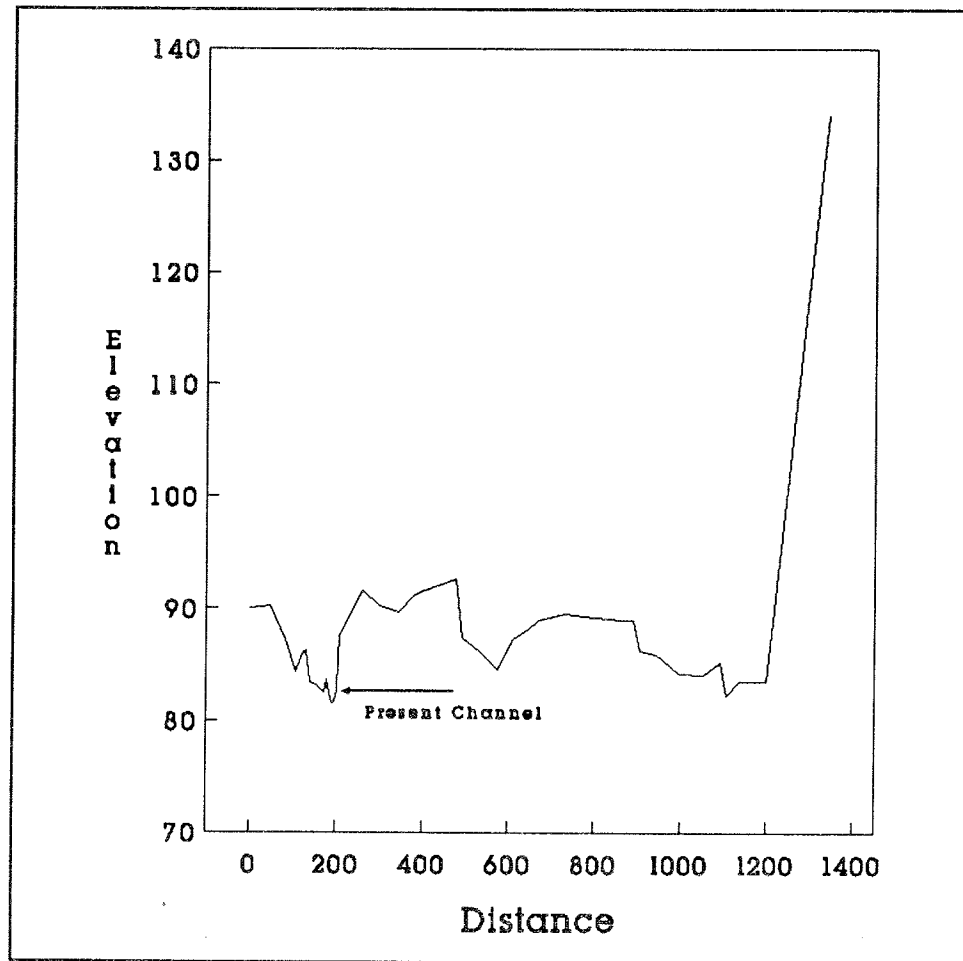
sediment. The stream in the area of the fan is less steep and unconfined by canyon walls. As the stream flows across the alluvial fan, velocity is reduced and much of the sediment load is deposited. As shown on Figure 2, the stream bed of Divide Creek in the vicinity of the developed area is at nearly the same elevation as its adjoining floodplain and, as a result, any deposition of material onto the bed encourages the stream to change course and find a lower portion of the floodplain. For this reason, the stream channel is very unstable and historically has shifted over a large area extending from near the town of St. Mary (present location) to a location near the historic St. Mary Ranger Station. Review of topographic maps suggests that the Divide Creek fan extends well into St. Mary Valley and may be responsible for splitting a large prehistoric lake into the two lakes present today, Upper and Lower St. Mary Lakes.

Figure 2. Profile of Divide Creek and floodplain in residential/maintenance area. Profile is perpendicular to channel, approximately 100 feet downstream of access road bridge.

Stream hydraulics were modeled using HEC-2, a water surface profile computer model developed by the Hydraulic Engineering Center, COE (US COE 1982). Flows required to reach the base and top of the floodwall assuming the present topography are estimated to be 6,000 and 16,000 cfs, respectively. Assuming 3 feet of additional deposition in the channel, the flow required to reach the base of the wall is approximately 1,500 cfs and to reach the top of the wall is about 9,000 cfs. The elevation of the floodwall is, therefore, adequate to provide a large degree of protection even with a few feet of deposition in the channel. However, the ability of the floodwall to structurally withstand the hydraulic forces exerted by high flows is questionable. Additionally, potential exists for undermining of the structure and circumvention of flow upstream. Thus, it appears that the major concerns in this area are the stability of the metal wall and preventing flow from circumventing the wall upstream at the nick point.

Structural improvement of the existing metal flood wall is recommended. The floodwall should be extended further upstream to the nick point and tied into the higher local topography. The floodwall, including its foundation should be evaluated for its ability to withstand the hydraulic forces of a design flood, such as the 100-year flood, and improved if necessary. Private property, east of the channel, should also be protected by an appropriately designed structure. The highway bridge should be enlarged or replaced by a bridge with larger flow capacity.

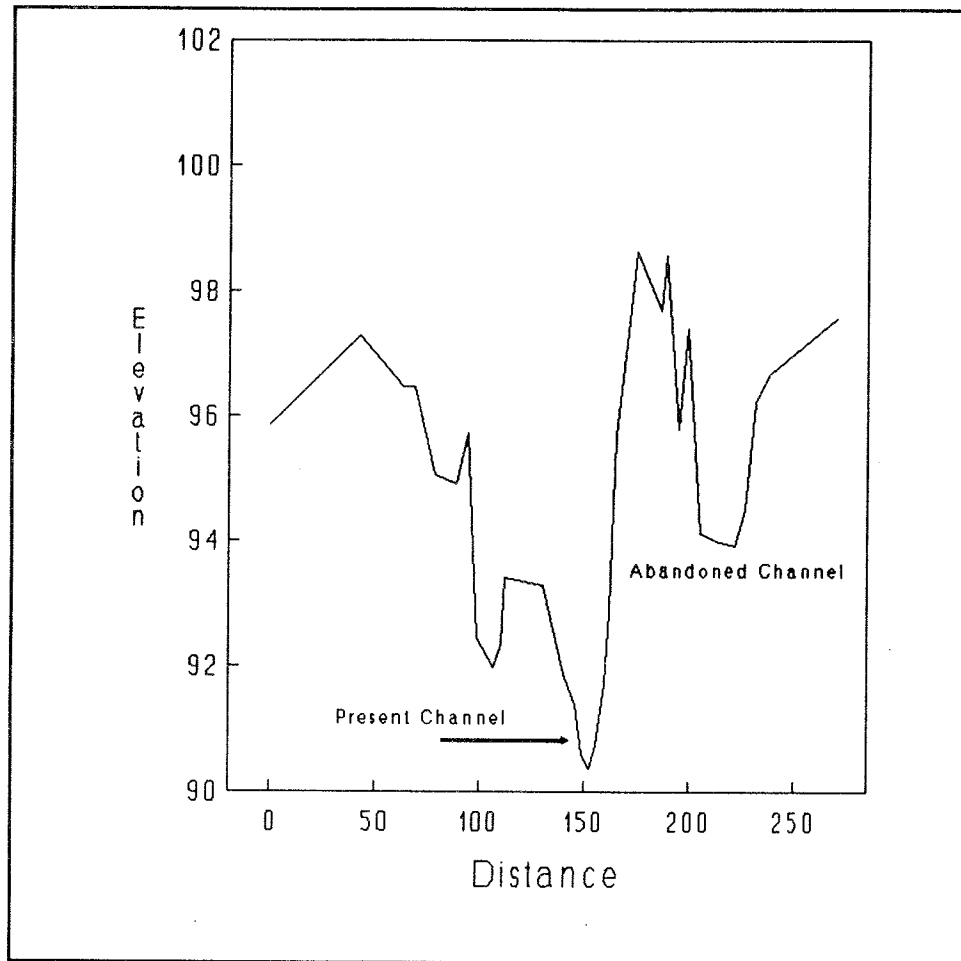
The nick point is located upstream of the maintenance yard, and is an area where the stream is presently attempting to change course. Abandoned channels are present at elevations lower than some areas of the current channel (Figure 3). A dike has been built of channel material and debris to prevent the channel from changing course and utilizing the adjacent abandoned channel. This abandoned channel runs through the developed area and would cause flooding if it were reclaimed by the stream. The nick point is upstream of the floodwall so any flows

Figure 3. Profile of Divide Creek at the "Nick Point".

A flow of about 3,000 cfs is predicted to reach the base of the nick point dike and would begin to cause instability due to the erosive, non-cohesive nature of the dike material. Hydraulic modeling with an assumed 3 feet of channel bed aggradation indicates a flow of about 3,000 cfs would reach the top of the dike. Due to the unconsolidated nature of the dike material, the dike could be expected to fail at flows much less than 3,000 cfs. Therefore, the combination of aggradation and high flows makes the dike a likely candidate for catastrophic failure. This type of failure would cause rapid flooding of the developed area with little or no warning and could result in loss of life and property.

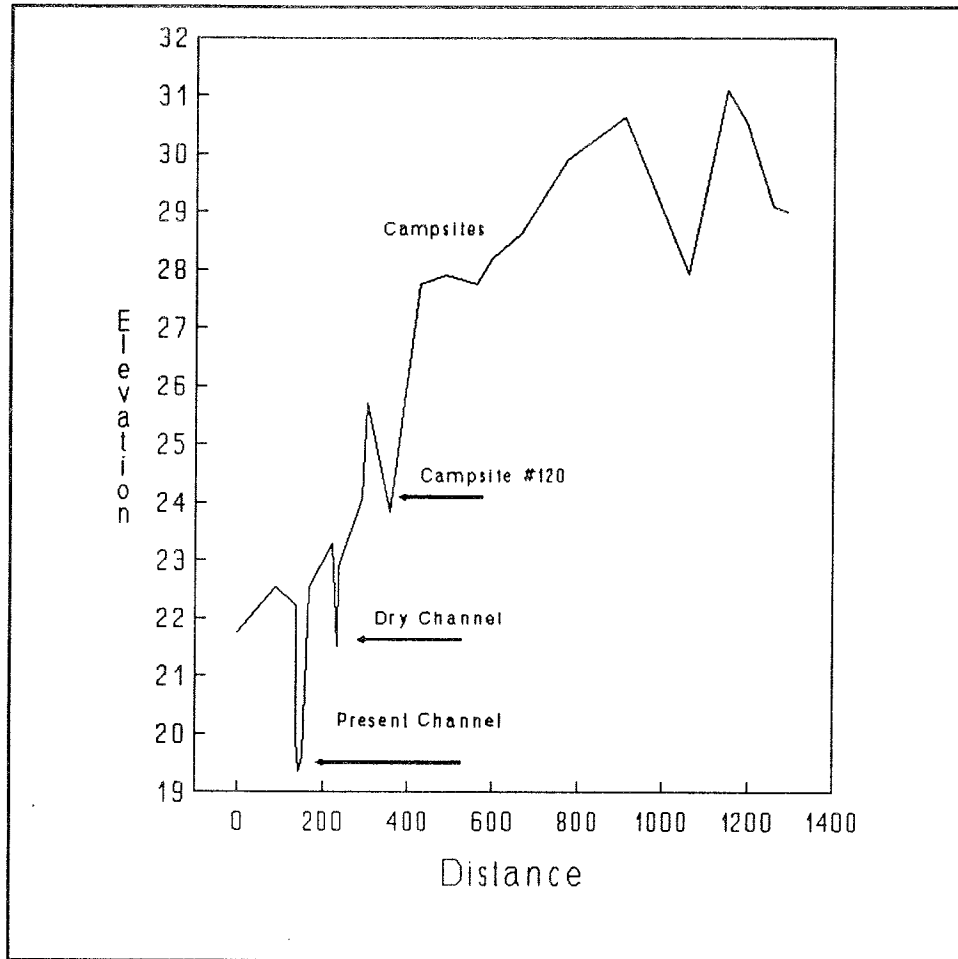
During the field trip two representative cross sections were surveyed through the floodplain in the campground area. One of these cross sections is shown in Figure 4. These cross sections reveal that much of the campground is well above

Figure 4. Profile of St. Mary Campground and Wild Creek

the Wild Creek channel and in little danger of flooding. Portions of the campground located near the channel, however, are susceptible to flooding particularly if aggradation encourages stream channel instability.

Hydraulic modeling was performed using HEC-2 to estimate the flow capacity of the existing channel. The present channel in the vicinity of the campground is estimated to be capable of passing approximately 500 cfs. This flow value is much lower than estimates of the 100-year flood which range from 980-1,350 cfs as derived from the same methods used in the Divide Creek analysis. With sediment deposition in the channel, flooding would occur at a much lower discharge indicating that flow outside of the channel can be expected on a fairly frequent basis in this area. Evidence of overbank flow is present in the eastern portion of the campground where an overflow channel has recently cut into the development. This channel directs flow toward the lower-lying area in the southeast part of the campground and may cause flooding in this area. Additional survey information is

Hazard to humans from flooding can be mitigated non-structurally by not using the flood prone areas of the campground during the peak snowmelt season. Also, the stream should be observed during unusually large summer thunderstorms and the lower portion of the campground evacuated when streamflow rises rapidly.
